Ghost nets in Danish waters

Appendices

DTU Aqua Report no. 394a-2021

These are appendices to the report “Ghost net in Danish waters” which is the final deliverable from DTU Aqua in the project drafted by the Danish Fisheries Agency about the occurrence of ghost nets in Danish waters.

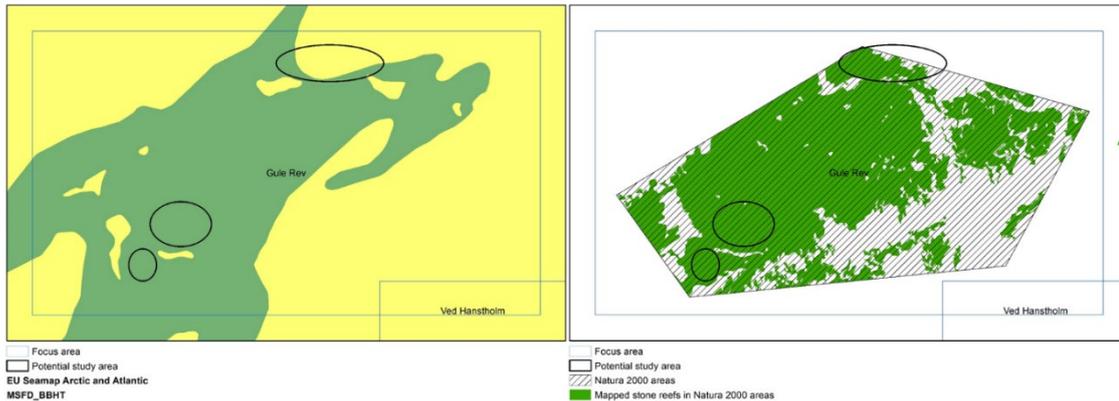
Figure 4. Left) The EUNIS habitat map for the Gule Rev area. Yellow is sand areas and green is mixed sediment. Right) The Gule Rev Natura 2000 stone reef area. ▨ Natura 2000 areas, ■ Mapped stone reef in Natura 2000 areas.

According to the EUNIS map the sediment type in Gule Rev area 1 and 2 is mixed and in Gule Rev 3 it is mainly sand, however according to Figure 4 (left) it is mapped as stone reef in a Natura 2000 area (Fig 4, Table 1).

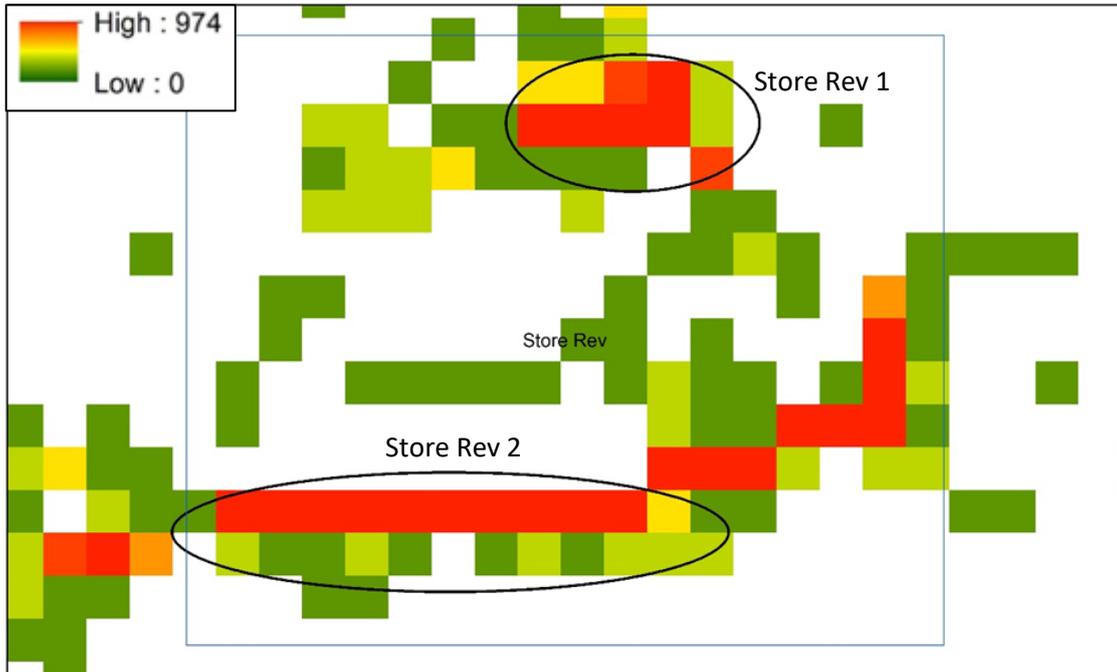
Figure 5. Map of the Store Rev focus area and the two potential study areas, showing the number of days with overlap between active and passive gears from 2018-2018 in a 1km grid.

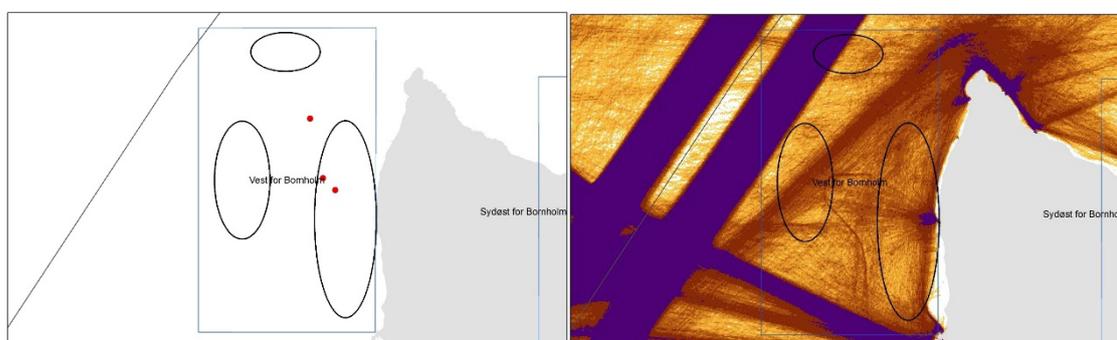
Figure 20. Left) Red dots indicate findings of >1 km old fishing nets within a 2x2 km square in a not yet published Swedish ghost net project. Right) AIS pings from marine traffic (2016) in the area West of Bornholm.

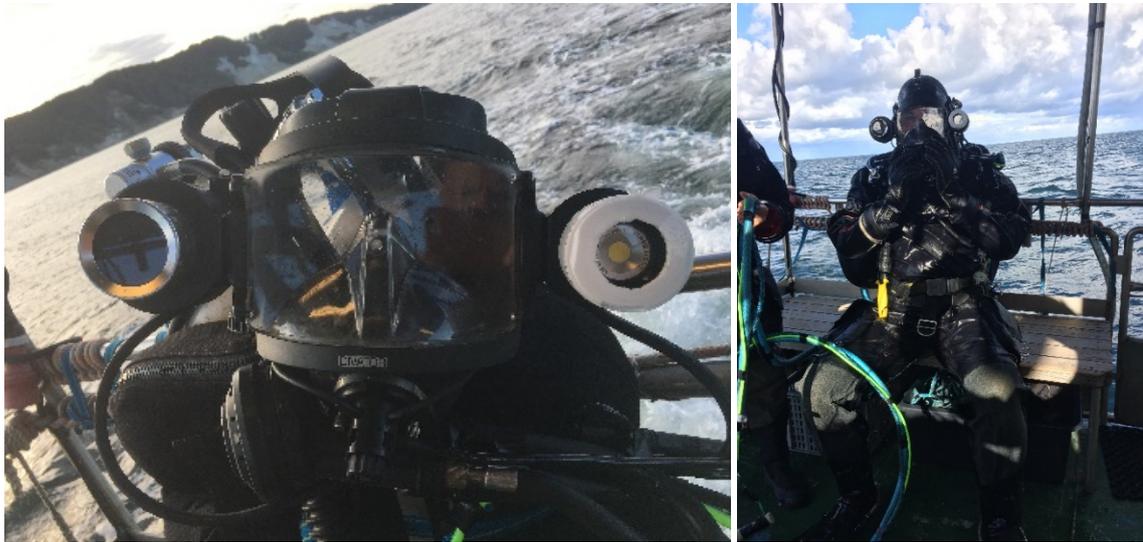
Figure 3. Left) The diving mask mounted with live streaming LH camera and one light. Right) Diver fully dressed and ready to dive

The divers were equipped with a LH-HD camera and one dive-light, with live signal transmitted to the surface. The camera was mounted on the right side of the mask and the dive-light on the left side (Fig 3). In addition, the divers were equipped with an Aquacom® MK2-DCI intercom

system in the mask, connecting the diver and the dive leader on the deck, thereby making it possible to direct and ask questions to the diver. The diver brought on every dive a 1-meter long measuring stick with 10 cm wide black and white stripes, to estimate the size of the findings.

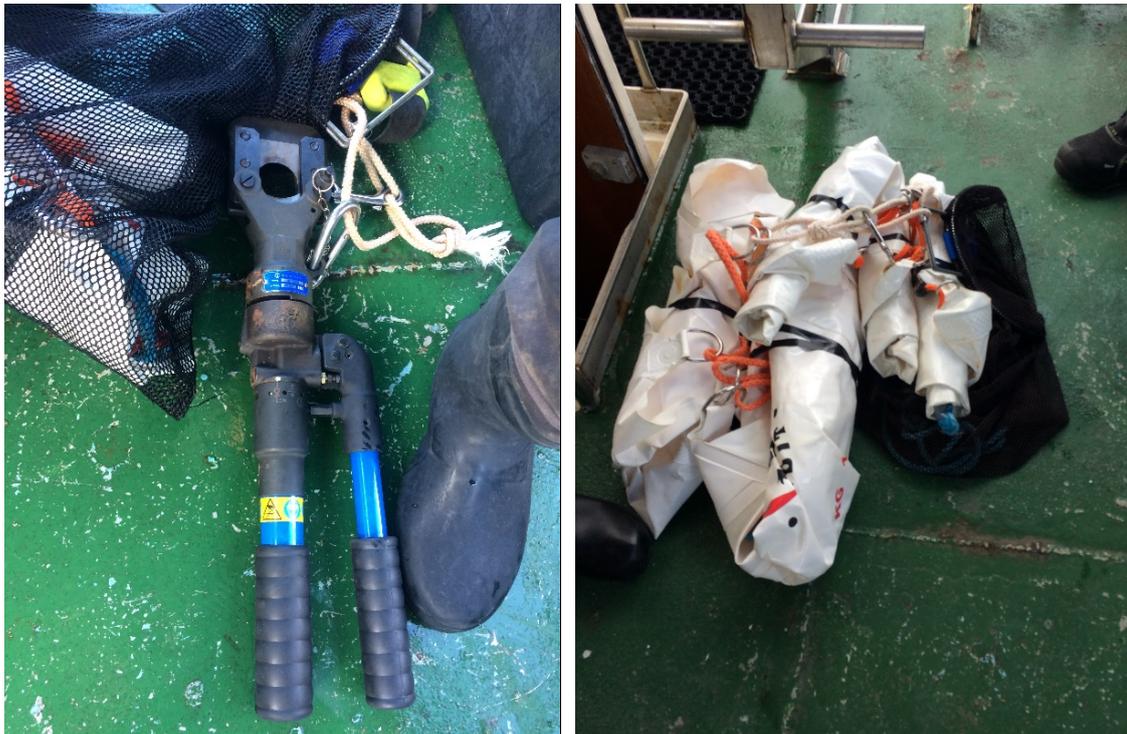
Figure 4. Equipment used for retrieving nets. Left) A wire cutter, Right) rolled up lifting bags.

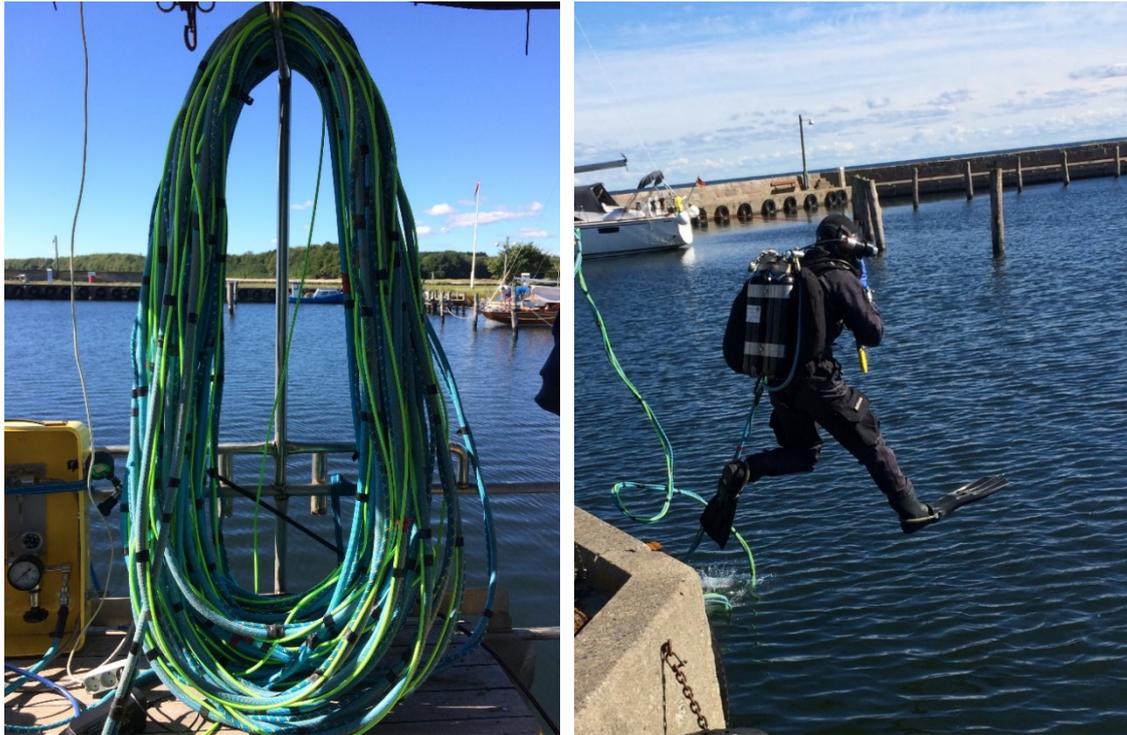
Figure 6. Left) Air cable and video cable tied together. Right) Safety drill dive in Hesnæs harbour.

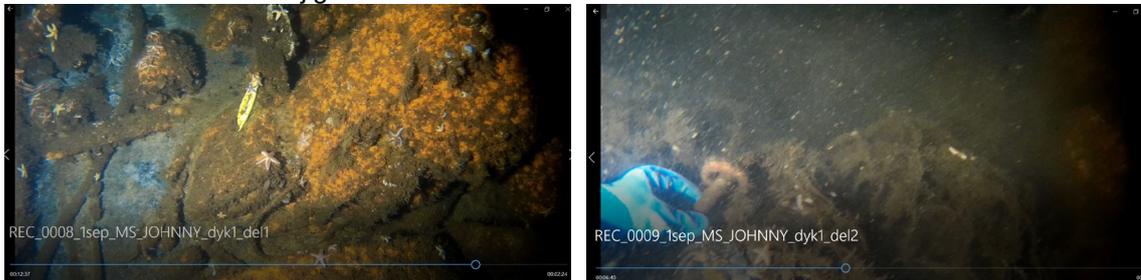
M/S “Johnny” is according to vragguiden.dk a wooden motor schooner that sunk in December 1948. It is largely covered in blue mussels. Based on the observations of mass death of crabs and black areas in the sediment, an oxygen depletion has recently occurred. 2-3 trawl pieces were observed and 6-10 jigs.

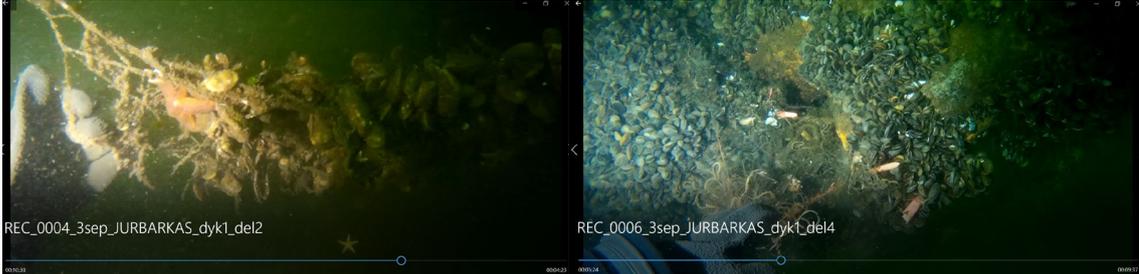
“Jurbarkas” is according to vragguiden.dk a 5387 BRT trawler, around 100 m long and 15 m wide. It is an iron wreck with a significant blue mussel fouling. The wreck was blasted by the Danish authorities following the loss and lies scattered on the sea bottom. Due its size only around 1/3 of the wreck was mapped. Three to four different nets were observed, all covered in mussels and around 10 jigs.

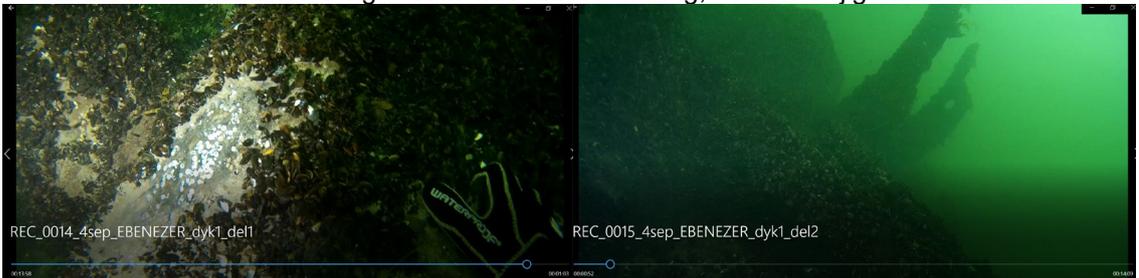
“Ebenezer” is according to vragguiden.dk a fishing vessel on 32 BRT that sunk in 1994; the masts are removed. It has a significant blue mussel fouling; no nets or jigs were observed.

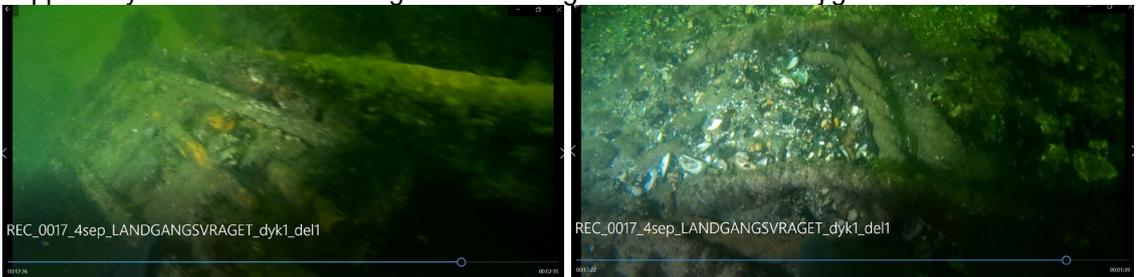
“Landgangsvraget”. No written information on the wreck but the local guides said it had supposedly been used for making landfall during the war. No nets or jigs observed.

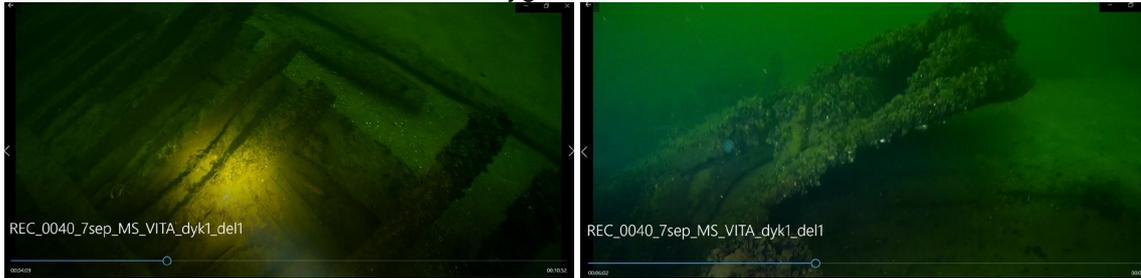
M/S “Vita” is according to vragguiden.dk a wooden motor schooner loaded with paper mass, which sunk in December 1944. No nets or jigs were observed on the wreck.

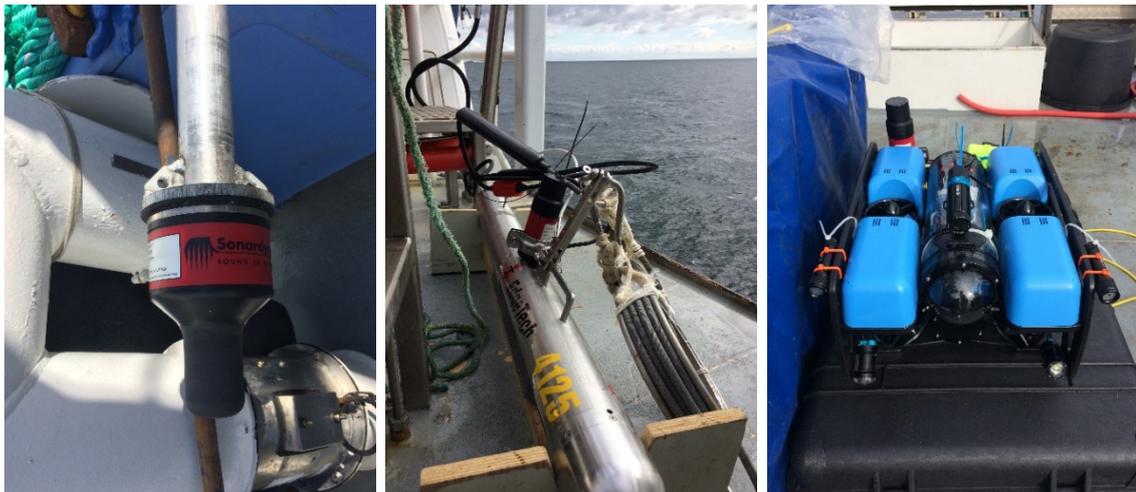
Figure 3. Images of the Sonardyne Micro-Ranger 2, USBL system used on the deployed equipment. Left) The pole-mounted transmitter. Middle) The beacon mounted on the sidescan sonar. Right) The beacon mounted on the BlueRov2. Photo DTU Aqua.

The equipment used for this mapping survey was a portable Edgetech 4125, 600/1600 kHz sidescan sonar with a 7 kg keel weight attached and equipped with a Sonardyne Micro-Ranger 2 USBL system, which again was connected to a DGPS (HGNSS-3276 Atlaslink A222 GNSS Smart Antenna). For ground truthing we used a BlueRov, a SeaRay, a Pralenz camera, a LH-HD camera and some GoPro’s (Fig. 3). In addition, we used Havfiskens SBE 19plus SeaCAT Profiler to measure the sound velocity in every area before deploying the USBL system.

The USBL system was set up and calibrated according to the manual in the harbour, prior to survey departure. Every day on arrival to the survey area or when entering a new area, a water profile was made on arrival to adjust the sound velocity for the USBL system. As an extra check the beacon was mounted on the CTD so that the depth measurement could be checked. Prior to every deployment of the sidescan sonar, the pressure sensor was checked to be zero or otherwise reset to zero on deck.

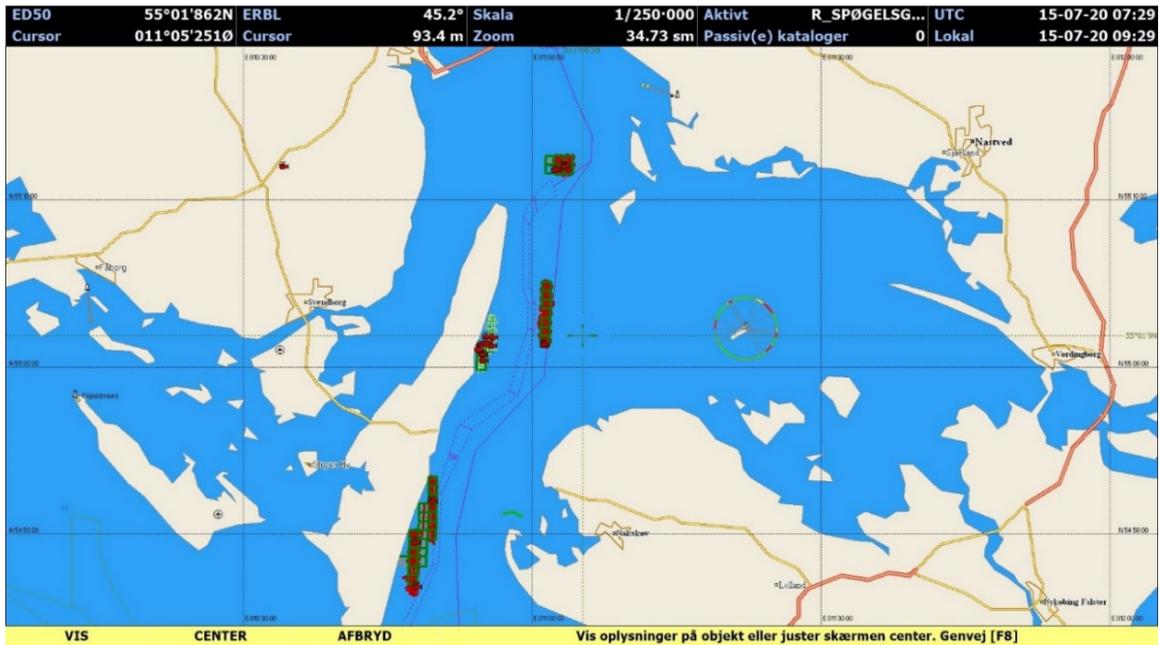
Figure 7. Print from the plotter system on “Havfisken” showing an overall map of areas surveyed with the sidescan sonar in the Langelandsbælt, July 2020.

During the eight-day survey a total of 31, 1x1 km squares was surveyed using the sidescan sonar, 9 of these were however only scanned in the three north-south going transect due to a mix of time limitation and a very shallow coastal area (the keel on “Havfisken” is 3.5 meters below the surface). All of these 9 transect were located in the Langelandsbælt 3 focus area. An overall view of the four survey areas can be seen in figure 7 and the sidescan sail routes can be seen for each area in figure 8. A summary over the daily activities can be found in table 2.

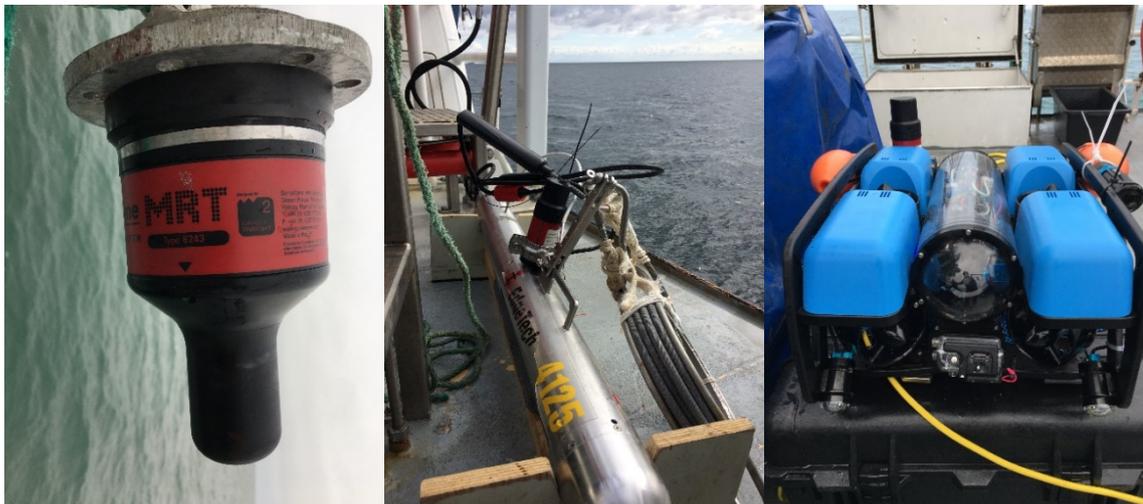
Figure 3. Images of the Sonardyne Micro-Ranger 2, USBL system used on the deployed equipment. Left panel: The pole-mounted transmitter. Middle panel: The beacon mounted on the sidescan sonar. Right panel: The beacon mounted on the BlueRov2. Photo DTU Aqua.

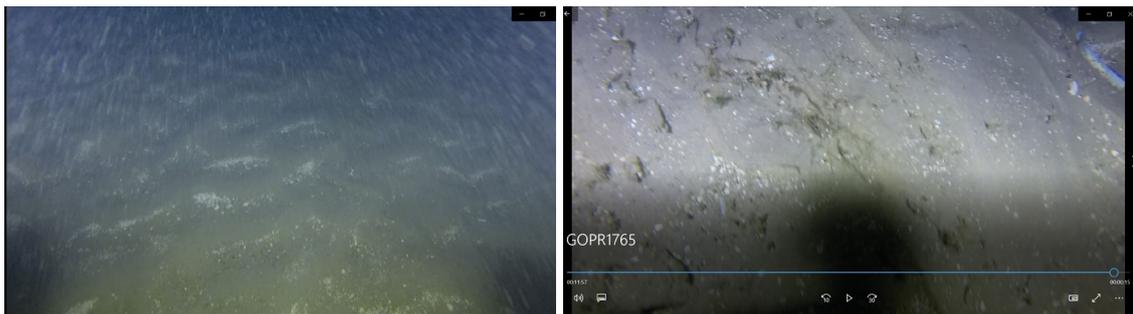
Two images from the GoPro mounted on the BlueRov used for ground truthing. A small piece of blue rope can be identified on the right-hand image.

The BlueROV mission had to be aborted due to a line in one of the propellers. However, on image #4 a small blue rope can be seen in the top right corner – this might be a part of the net that was later retrieved. When the BlueRov was on deck, an attempt of dredging at the targets was made. A 240 m long crab net (gillnet) was caught including an anchor, a buoy and 60 m of blue flag line. In the net was 70 brown crabs weighing in total 40 kg. No dead brown crabs were observed in the net. Details on the recovered material can be found in appendix. A.19.

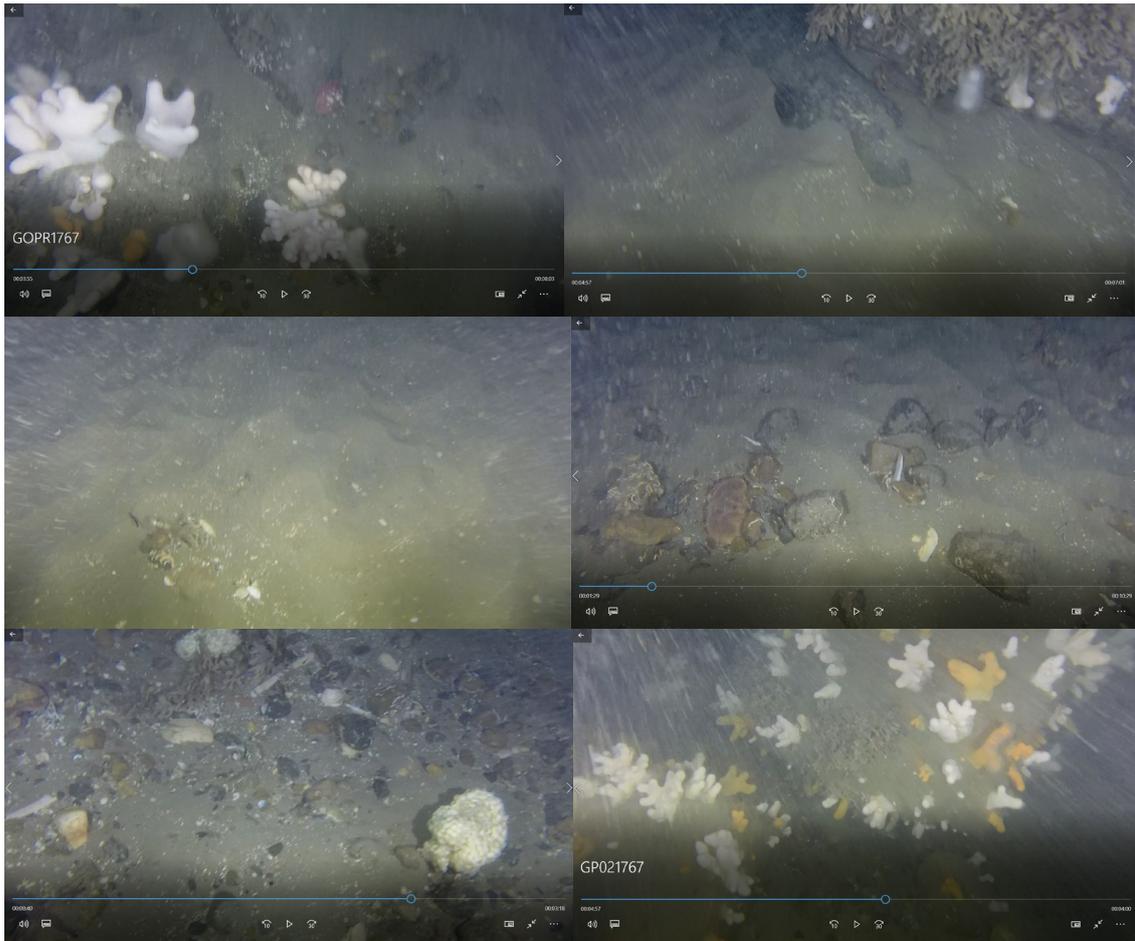
*Selected images from the GoPro mounted on the BlueRov used for ground truthing, showing boulders and stones covered in soft coral (*Alcyonium digitatum*), mixed bottom with brown crab, and sandy bottom.*

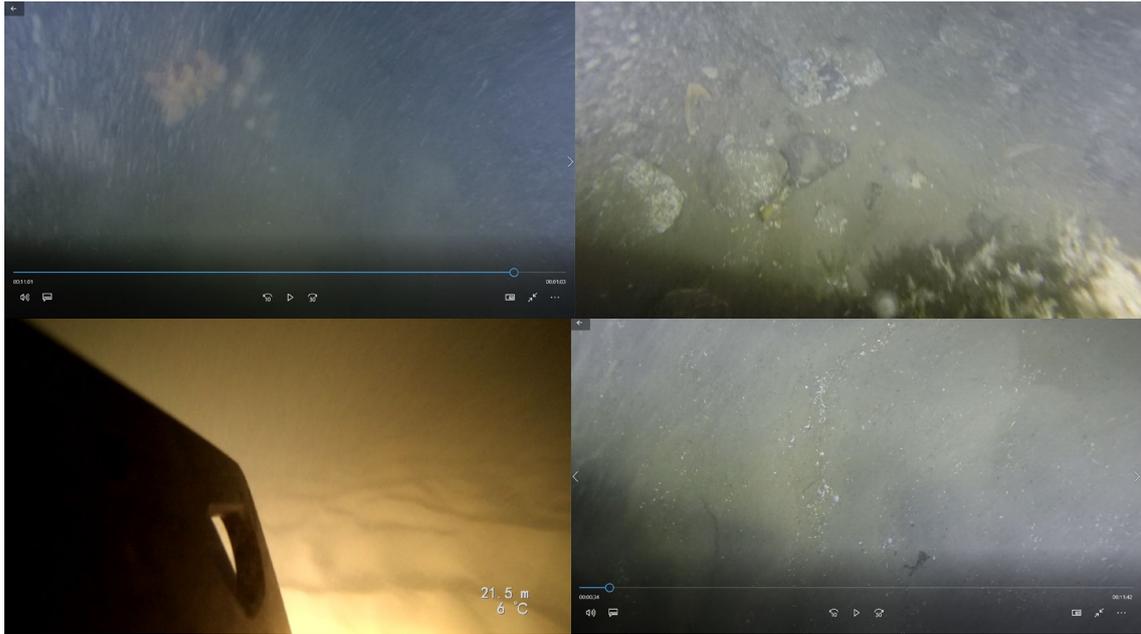
Selected images from the GoPro and Paralenz mounted on the BlueROV used for ground truthing.

Target 331-332 (January 18th 2021) in Jammerbugt study area 2 was ground truthed on January 18th using the BlueROV with the Paralenz and a GoPro camera. The entire study area was appointed as a sand area but was generally a mixed area with stones on sand. Two ground truthing trials were made with no observation of unnatural structures. By the end of the second trial, the ROV was stuck under the boat but was recovered without any further damage than loss of a float.

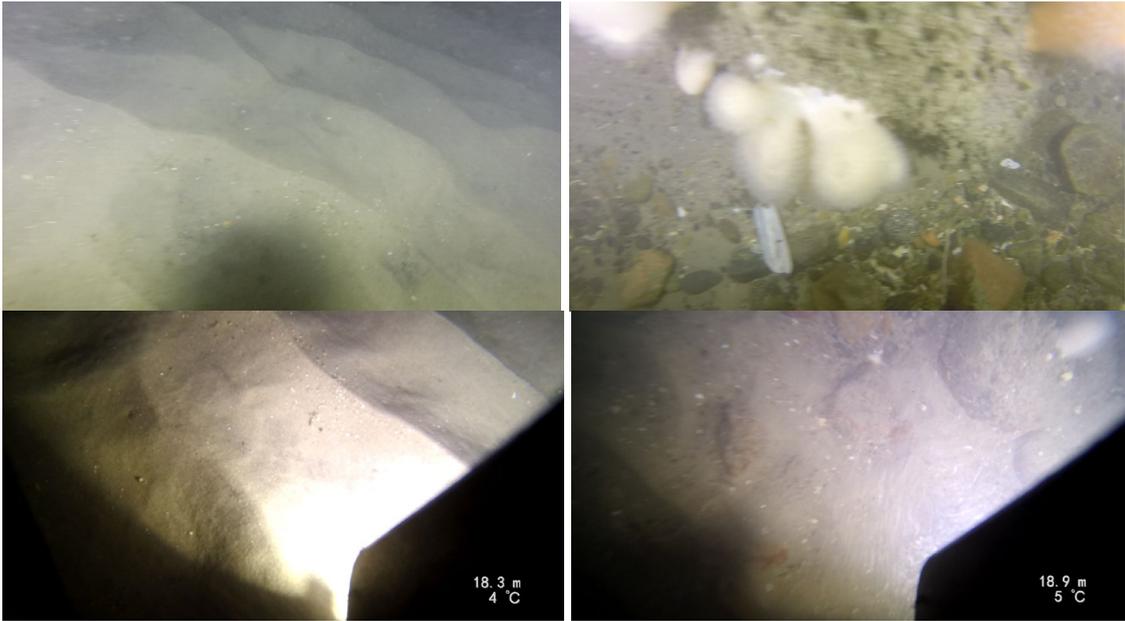
Selected images from the GoPro and Paralenz mounted on the BlueRov used for ground truthing.

Target 411-414 (January 19th 2021) located in Hirtshals study area 1 was ground truthed on January 19th. The appearance of target 412 was similar to target 282, which proved to be a net. Therefore, three dives were made with the ROV to identify the structure, but without any luck. The majority of the area was fine sand, right up to the edge of the stone reef as target 414 nicely illustrates. Images of sand and the reef can be seen below. Due to the similarity of target 282 it was decided to drag for the item at the sandy area, but none unnatural items were caught.

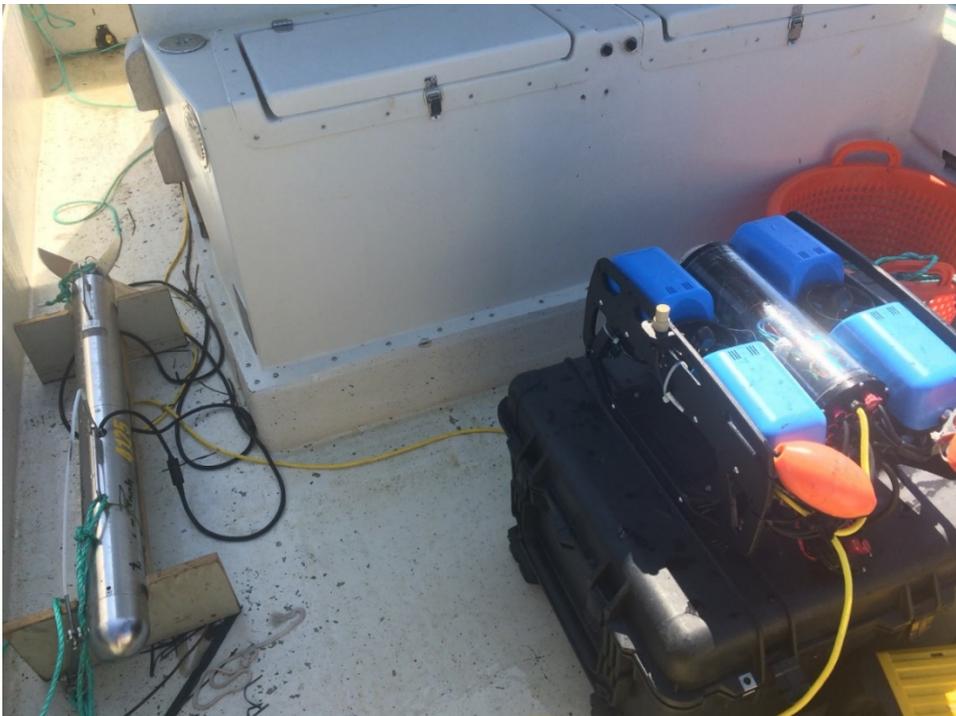
Figure 3. Edgetech sonar and BlueROV2 Vehicle aboard Fjordrejen during transit

The Danish Shellfish Centre's 6 m vessel, *Fjordrejen*, was the principal vessel used for towing the sidescan sonar. An Edgetech 4125 dual frequency sidescan sonar 600/1600 kHz was hung from the starboard side of *Fjordrejen* at approximately 60 cm below the waterline, enough to allow the transducers clear soundings beneath the hull. The Edgetech system was supported with an Atlaslink A326 Smart Antenna GPS as the principal navigation aid. The antenna was set 2.5 m above, 2 m aft and 1 m to port of the towbody. The nominal range of the sonar was set to 25 m on either side of the tow body. Post-processing of the sonar data was performed using SonarWiz v7.08.00. A Blue Robotics BlueROV2 unit was also included to provide visual confirmation of marked targets (Fig. 3). Kasper Andersen from DTU's Shellfish Centre acted as pilot for *Fjordrejen* and assisted with setup, deployment and retrieval of equipment. Fletcher Thompson from the Observation Technology group acted as operator for the sidescan sonar and BlueROV2 and was responsible for processing of the collected data. Daniel Taylor from DTU's Shellfish Centre assisted with repair of the damaged sidescan sonar cable.

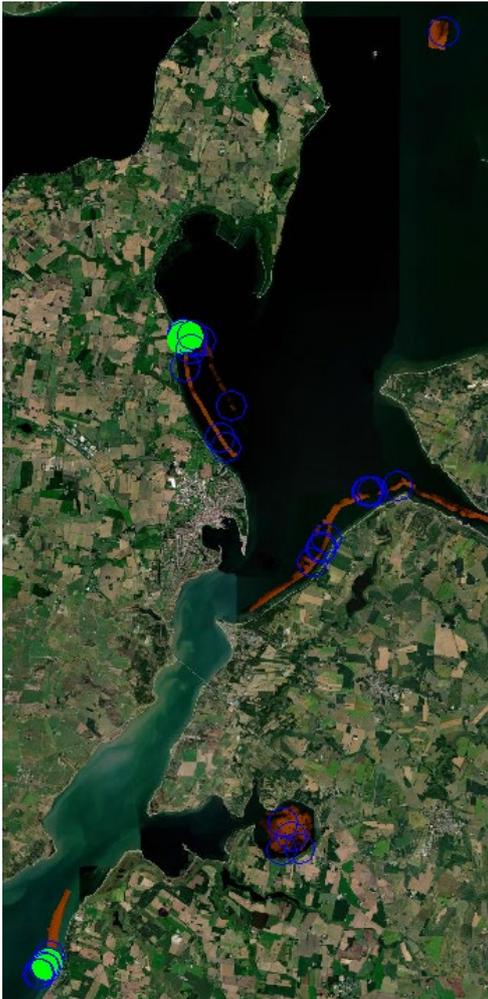
Figure 4. Accumulated coverage of the survey, ranging from latitudes 56° 39' to 56° 57' and longitudes 8° 56' to 9° 1'. Unconfirmed targets are listed as blue rings, confirmed ghost nets are identified as filled green circles.

The areas in figure 4 were covered over four days. Targets identified during the survey are displayed as either blue rings (unconfirmed sonar targets) or filled green circles (confirmed ghost nets). Multiple ghost nets were sighted, indicating that at least two ghost nets were present (it was difficult to confirm whether multiple sightings in an area were part of the same net). In total 40 targets were identified, with 6 of the targets belonging to visually confirmed ghost nets.

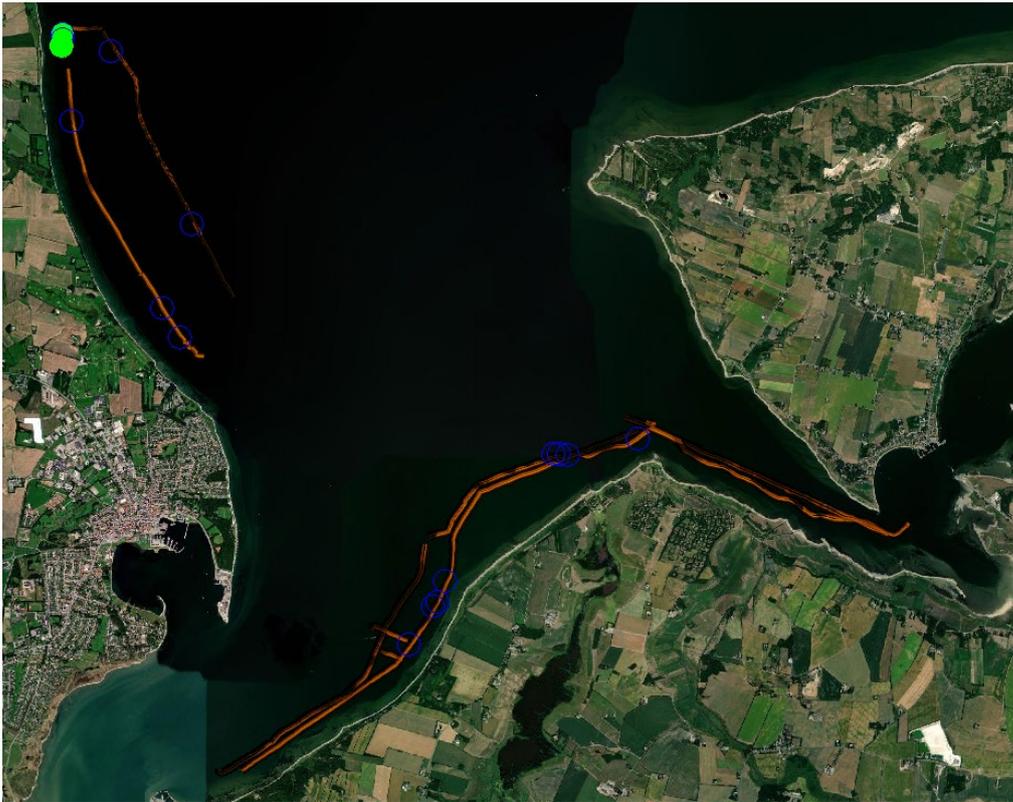
Figure 5. Coverage for day 1 of the survey. Areas were identified from the Shellfish Centre's report on lobster and crab fishing areas for 2020-2021

Marked mussel farms prevent complete “lawnmower” pattern coverage surveys in the area, so a simple boundary survey of the farms was conducted to cover two separate survey areas as quickly as possible (Fig. 5). There were many sonar contacts identified along the boundaries of the mussel farms. This is likely because the nutrients released to feed the mussel beds is an easy food source for lobster, and the fishers have identified this behaviour.

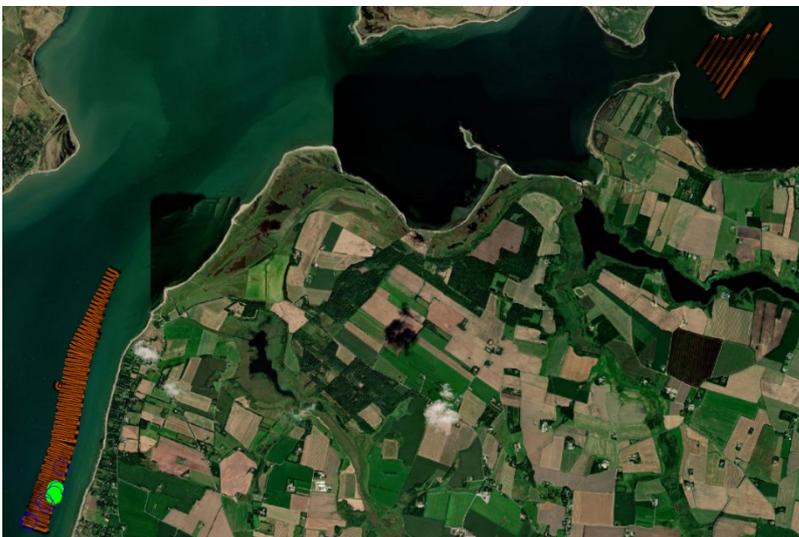
Figure 9 Coverage area for day 3. Areas (Nymølle Strand, and Harre Vig) were indicated by local fishers as roundfish and flatfish fishing grounds. At least one ghost net was identified in the southern sections of the survey (see green marks & Fig. 10).

Two fishing areas were surveyed further south of Nykøbing Mors (Fig. 9). The southern area contained one confirmed fishing net (Fig. 10), likely a gillnet.

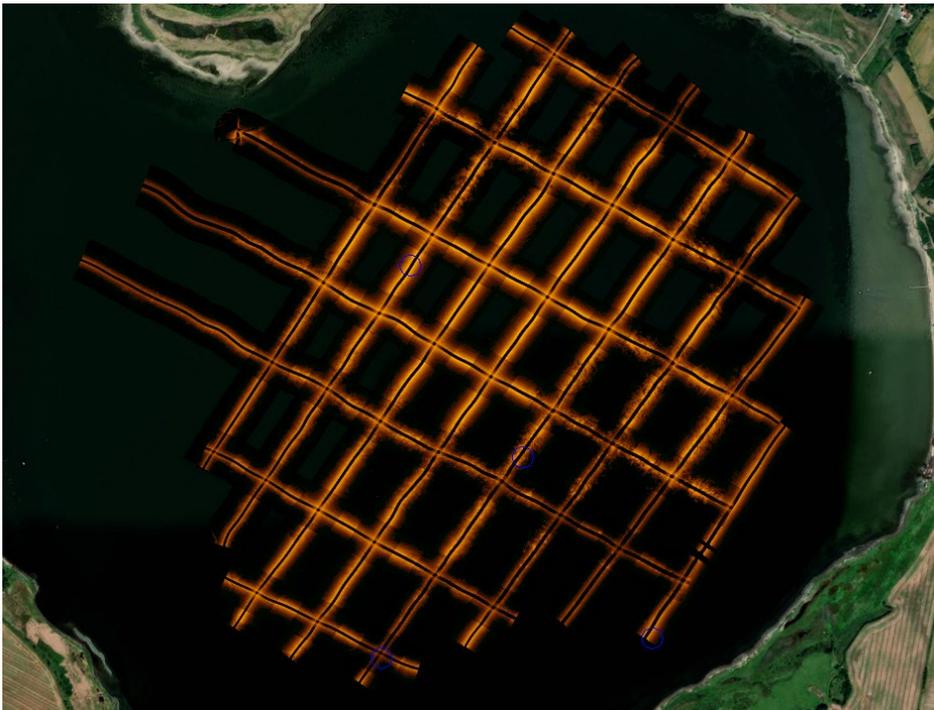
Figure 11. Covered area in Harre Vig for day 4.

The final day of survey finished off the remaining area of Harre Vig (Fig. 11). The charted depths in this section were untrustworthy, which resulted in some deviations from straight line transects to avoid grounding. The area is popular for anchoring of sailing yachts. Targets were identified in the area, but all were confirmed to be false positives produced by anchors creating drag marks on the muddy bottom se example in figure 12.

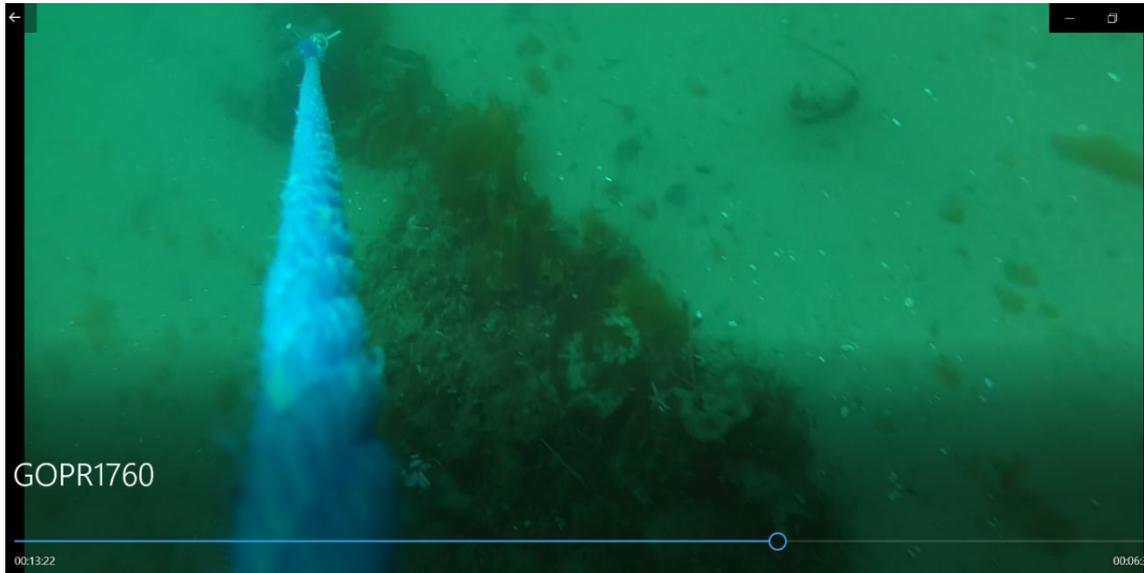
Dredging for a ghost net in Øresund 2021. Photo DTU Aqua.

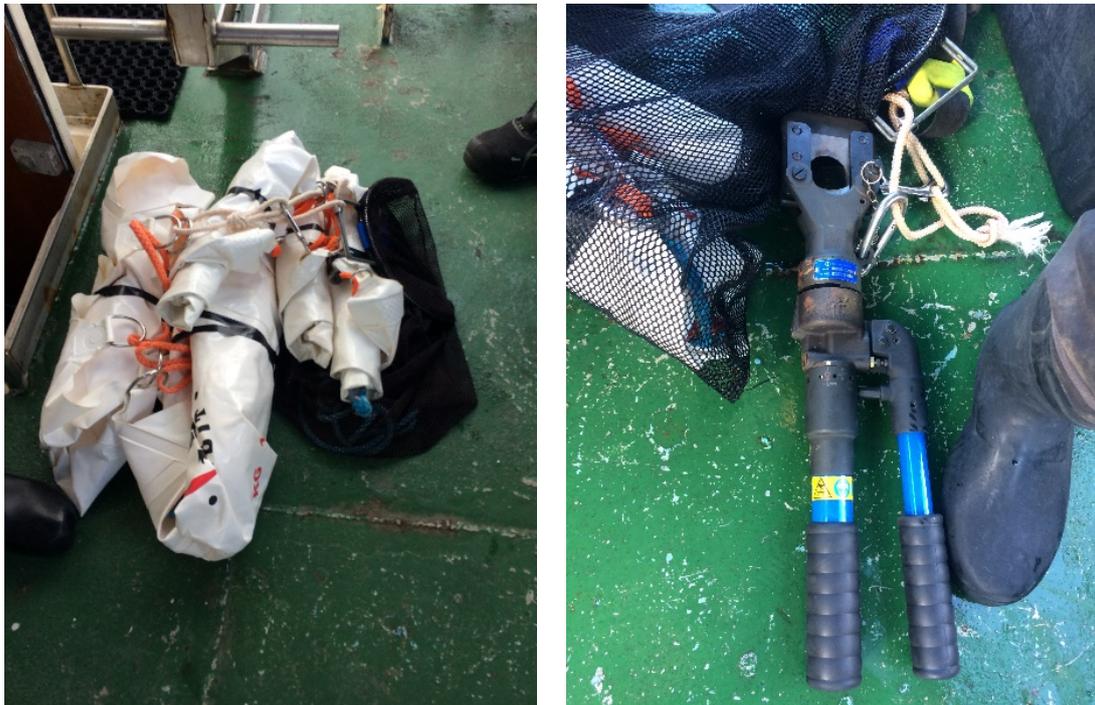
Figure 1. Left) A selection of different sizes of rolled up lifting bags. Right) A hydraulic cable/wire/rope cutter.

- Diver #1 documented and described the ghost net and how it was situated on the wreck, so that a plan for the cutting and release could be made and the appropriate equipment prepared.
- Diver #2 brought the appropriate equipment, usually a hydraulic cable/wire/rope cutter, an extra knife, lines and rope to tie the ghost net together and a number of lift bags (Fig. 1). The net was cut and released from the bottom or the structure on the wreck, where it was caught (Fig. 2, 3 & 5).
- The net was prepared for retrieval, by tying it up and attaching the lift bags to the net. The material was then raised from the wreck to the surface by inflating the lift bags with air (Fig. 2, 4 & 5) and getting the recovered material onboard the vessel by a small crane.

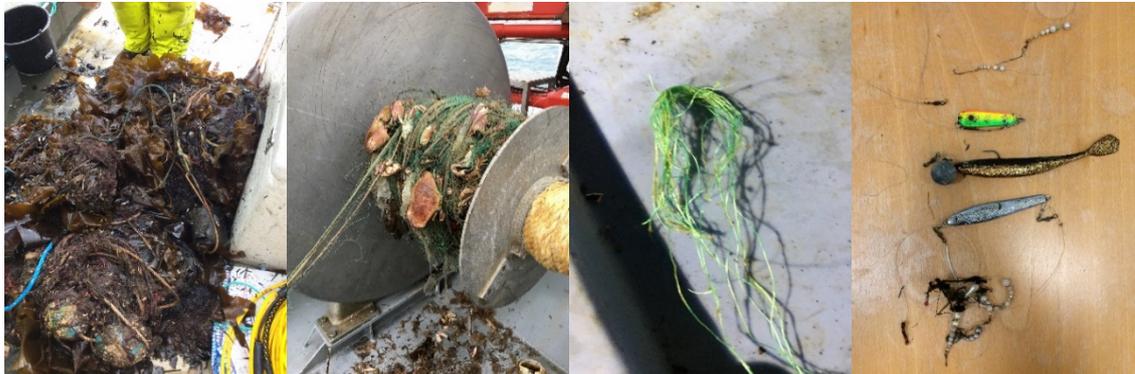
Figure 8. Ghost nets retrieved by dredging. 1) A gillnet for fishing cod/flatfish retrieved outside Lynetten in Øresund. 2) A gillnet for fishing brown crab, retrieved outside Hirtshals in Skagerrak. 3) Fibres from what is assumed to be a trawl, caught around Store Rev in Skagerrak. 4) Angling equipment attached to the gillnet from Øresund.

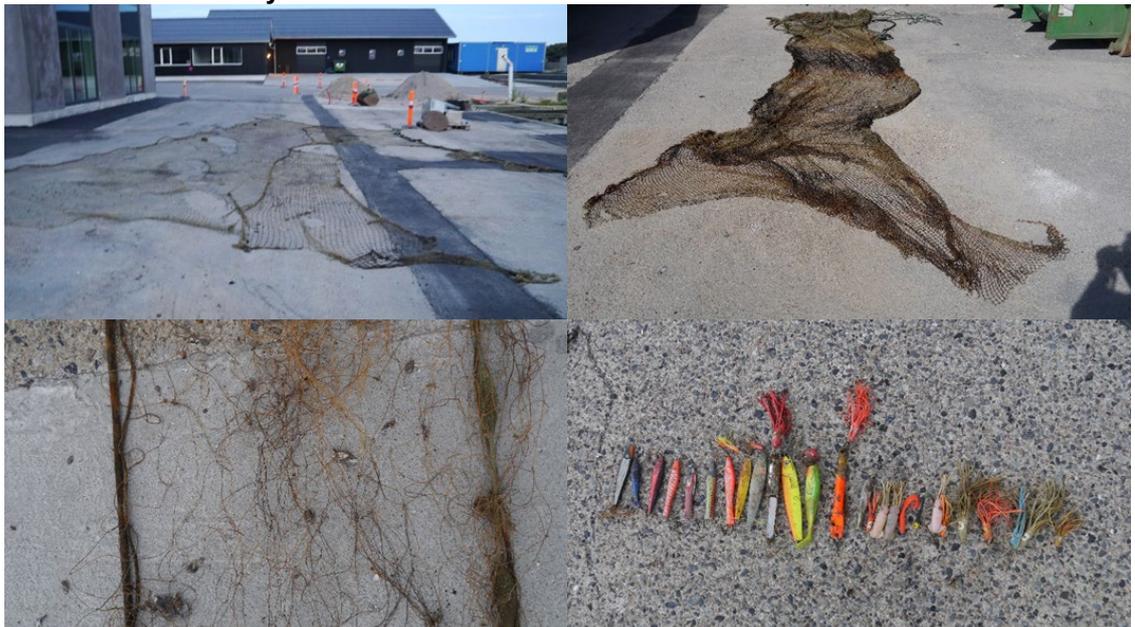
Figure 7.2.9. Examples of the fishing gear retrieved by divers. Top left) The mouth of a small trawl. Top right) A cod end from a trawl. Bottom left) A gill net with sink line. Bottom right) Jigs and other angling equipment attached to nets retrieved from the wreck “Jurbarkas”.

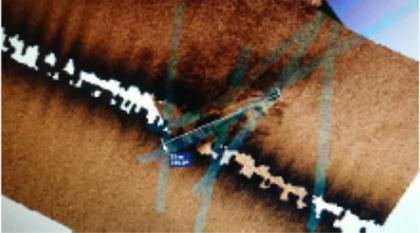
Skematisk tegning af hvor på vraget redskaber er observeret (Angiv på tegningen i hvilken retning stævnen på skibet ligger):

- 19:40 Start
- 19:41 Mange døde krabber, stor pilk
Net på ca 2m² med maskestørrelse på 2x2 cm
Meget sportsfisker udstyr
- 19:44 2 små pilke på ca 10 cm.
Mange døde krabber
- 19:45 Er ved agterenden af skibet
- 19:46 Svømmer mod stævnen midt over vraget
- 19:47 Er ved motor området hvor der observeres net+ kroge
- 19:48 Der observeres reb og net på ca 1m² med orange/røde ringe som i et løft. Er ca ved motorrummet ved styrbord side
- 19:50 Ved motoren
- 19:51 Trawl ned ringe (som i løft), mest krabber i nettet – ingen fisk
- 19:54 Fiskeline
- 19:55 Er ved stævnen
- 19:56 Svømmer på tværs og observerer fiskekroge/pirke
- 19:57 Fiskeline
- 19:58 Er ved motoren igen, det observerede trawl omdefinieres til ca 1x0,5m
- 20:00 Styrbord yderside, agter. Net på ca 1x0,2m
- 20:02 Tjekker bundtypen
- 20:03 Svømmer mod ankeret
- 20:05 Er ved ankeret
- 20:06 Begynder opstigning

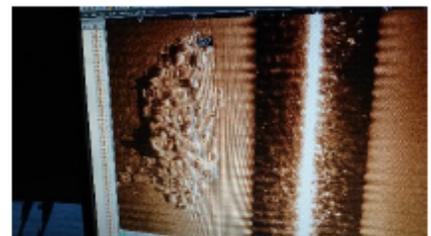
Navn på første fil: <u>REC_0003_3sep_JURBARKAS_dyk1_del1</u>					
Redskaber observeret på vrug: Nej <input type="checkbox"/>		Ja <input checked="" type="checkbox"/> , hvis ja hvilken type: Trawl <input type="checkbox"/> , Garn <input checked="" type="checkbox"/> , Andet <u></u>			
Hvis redskaber bjerget: Estimeret mængde <u></u> kg , Redskabstype(r) <u></u>					
Separat skema om fangst/begroning udfyldt		Ja <input type="checkbox"/>		Nej <input type="checkbox"/>	
Kommentarer fra dykker omkring observationer:					
<ol style="list-style-type: none"> 1) Net: 8x8 cm maskestr. 80x20 cm er første estimat af størrelsen. Ved næste dyk viser det sig at nettet går 8 meter ind i skibet (bjergning) 2) Net: 8x8 cm maskestr. Rulle, 1,2 meter lang. 3) Flere net + fiskeline. 8x8 cm maskestr. 80x10 cm. To farver; grøn og anden farve. 4) Pilke + fiskeline 					
Andre noter:					
Kun ca. 70 x 5 meter afsøgt af den nordvestlige del af skibet afsøgt. Det vurderes at dette udgør ca. 15 % af det samlede areal. Vraget stikker ca. 4 meter op nogle steder.

Vraget er sprængt, derfor mange løsrevne dele. 3 – 4 meter sigtbarhed.					
Til højre ses et sidescan billede af vraget.					
Skematisk tegning af observationer angives på bagsiden → (VEND PAPIR)

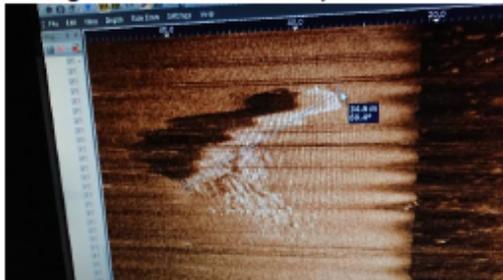
Navn på førte fil: <u>REC_0028_6sep_VIBEKE_HØJ_dyk1_del1</u>			
Redskaber observeret på vrug: Nej <input type="checkbox"/> Ja <input checked="" type="checkbox"/> hvis ja hvilken type: Trawl <input checked="" type="checkbox"/> Garn <input type="checkbox"/> Andet <u></u>			
Hvis redskaber bjerget: Estimeret mængde <u></u> kg, Redskabstype(r) <u></u>			
Separat skema om fangst/begroning udfyldt Ja <input type="checkbox"/> Nej <input type="checkbox"/>			
Kommentarer fra dykker omkring observationer:			
Trawlen ligger lige ved roret og hen over.			
Vraget er mest begroet med muslinger og enkelte krabber			
Andre noter:			
Vraget er en stempram der ligger på bagbord side. Den er forlist i 1977 og der er 2 store lastrum fyldt med sten.			
Til højre ses et sidescan sonar billede af vraget.

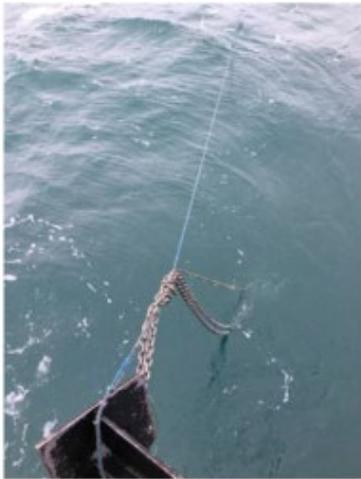
1

1. The catch of the ghostnet on the drag, the blue flagline can be seen. 2. The ghostnet including many of the crabs which could not be removed during the recovery. 3. The net spread out on the dock in Hirtshals. 4. A closeup of part of the net. 5. A closeup of the rope (tælle) on the gillnet. 6. The plastic and metal catch in the net. 7. The bamboo fishing buoy 8. The Anchor attached to the net. 9. A bundle from the ghostnet

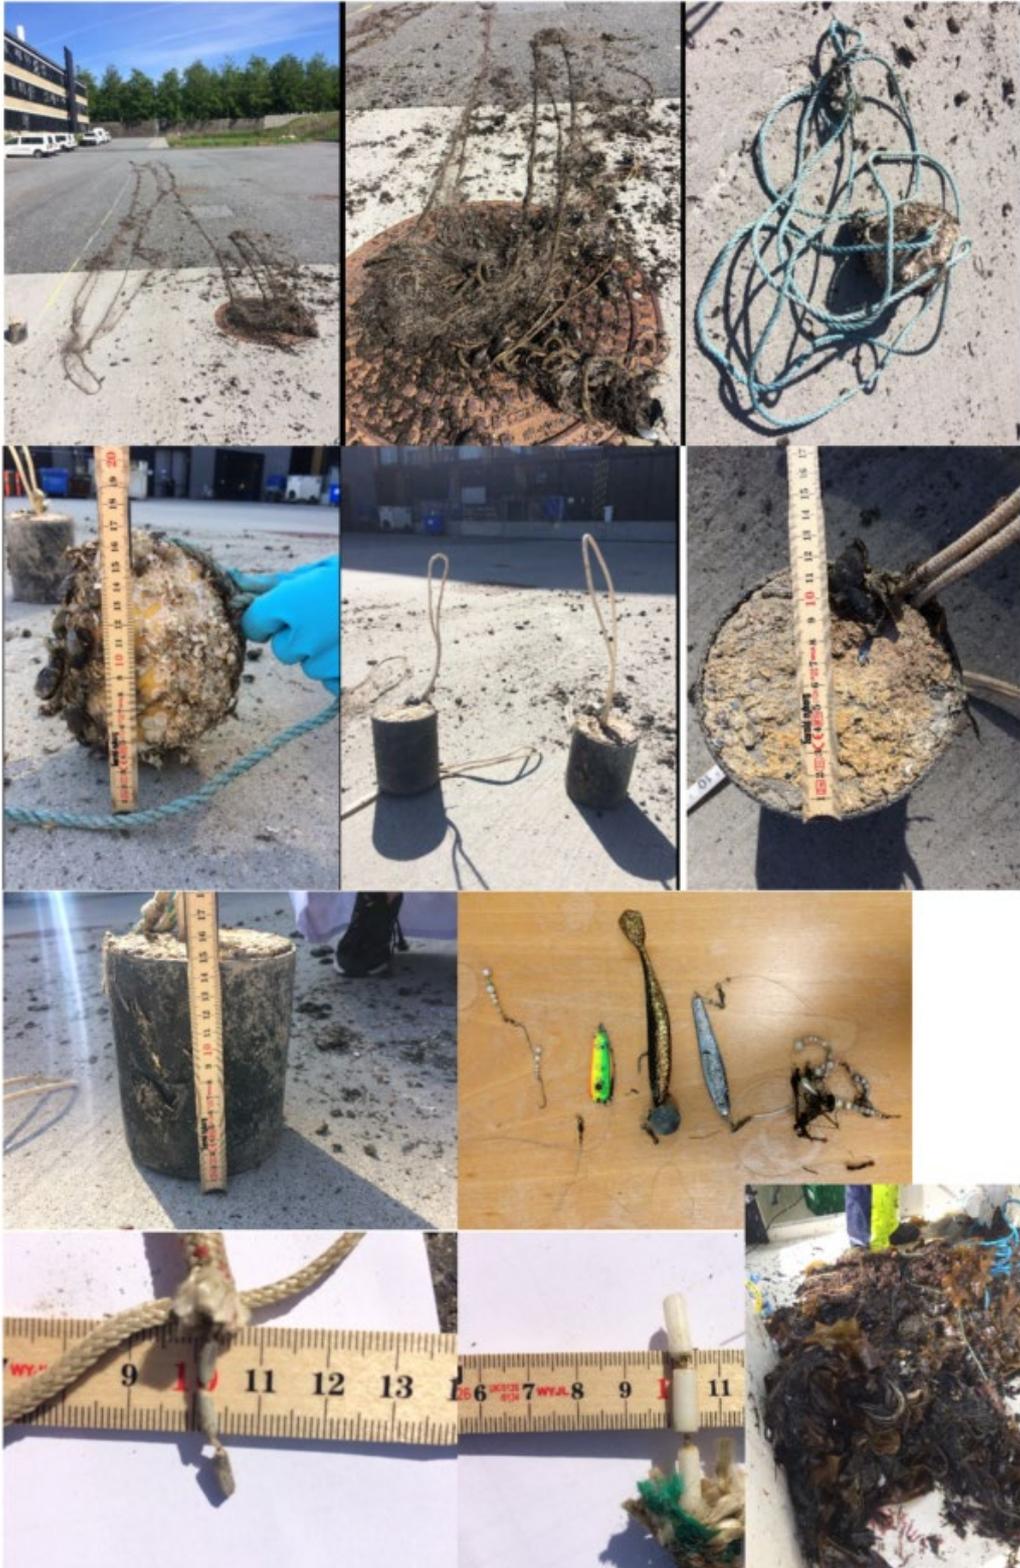
Type	Længde (m)	Vægt (kg)	Kommentarer
Ca. 3 torsk/fladfisk garn m tæller, 70mm masker	Ca. 70 m	Ca. 4	sandsynligvis fritidsfisker redskab
Blåmuslinger		<u>Ca 15</u>	
2 stk. hjemmelavede <u>ankere</u> , beton i plastik rør		<u>Ca 5</u>	
3. stk. opdrifts kugler		<u>Ca 1</u>	
Laminaria (brunalge)		15	
Enkelte strandkrabber			
3 stk. pirke, og nogle forfang			
Blå flagline	5,25

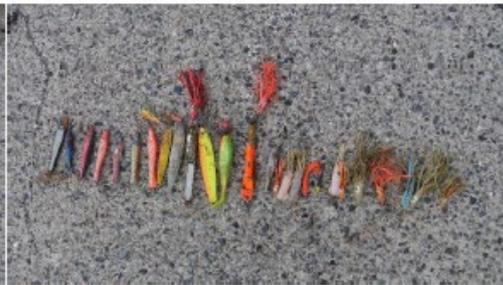
Foto: P1070424

Art	Længde (cm)	Vægt (kg)	Kommentarer
28 stk. lystfiskerudstyre, f.eks. blæksprutter og pirke		2,0	Foto P1070424
Sort net uden tæller	Filtret	0,5	Foto 1, prøver hjemtaget
Grønt/Brunt net uden tæller	Fitret	0,1	Ikke foto, prøver hjemtaget
Blyundertælle	1,7	} 3,5	
Blyundertælle (3 blyliner)	1,6		Foto P1070438
Blyundertælle	2m		Foto P1070433
Garn inkl. over og undertælle, ca 30 masker højt.	14m		Foto P1070432, prøve hjemtaget
Diverse jern		3,25	Foto P1070430
Ledning	3m	0,5	Foto P1070430
Diverse plastik		1	Foto P1070428, 2
Blåmuslinger		Ca 5 kg	Foto P1070436
1 stk søstjerne			
1 stk. levende krabbe			
2 stk halve krabber
