Ghost nets in Danish waters

Appendices

DTU Aqua Report no. 394a-2021

These are appendices to the report “Ghost net in Danish waters” which is the final deliverable from DTU Aqua in the project drafted by the Danish Fisheries Agency about the occurrence of ghost nets in Danish waters.

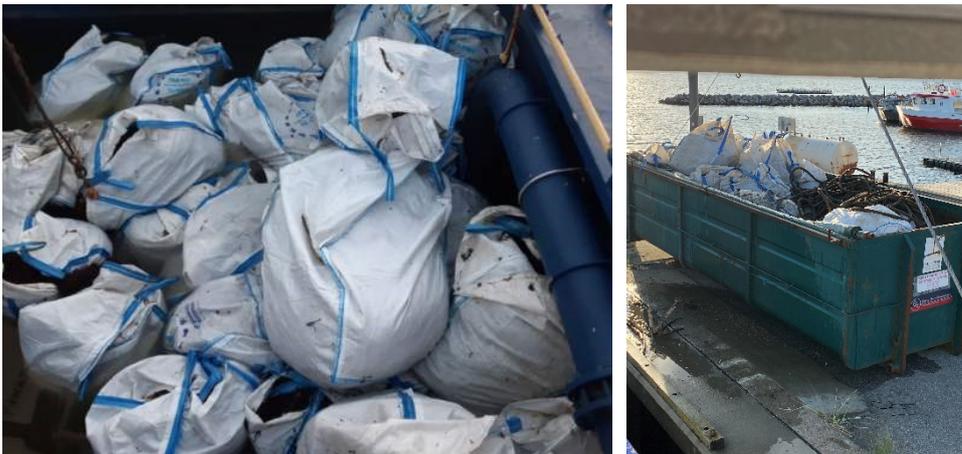
The result of the joint effort in Nissum bredning (Photo Flemming Johannesen & Knud-Erik Jacobsen)

Almost 17 ton of retrieved material was brought to Reno Nord in Aalborg for incineration, but prior to this the recycling potential of the material was evaluated by Plastix from Lemvig. Due to a combination of much biological material on the nets, the average age of the nets and the general mix of materials in the gear, like lead and polypropylen (PP) in the sinking ropes and multiple plastic types in the floating ropes, a lot of working hours would be required to separate the materials, it was therefore assessed that the effort did not measure up to the potential recycling result. In addition 26 bigbags were handled by the municipality of Morsø.

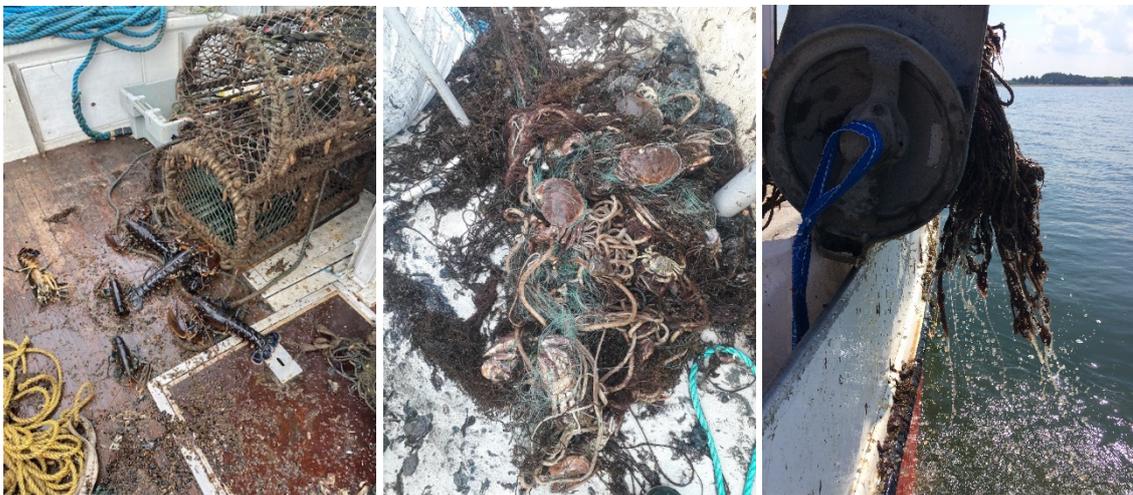
Left and middle. Ghost fishing of lobster and brown crab by pots and gillnets respectively. (Photo Leo Andersen & Peter Pedersen). Right. Retrieval of a ghost net.

overgrown by tunicates, algae and mussels. In these old nets bycatch of lobsters or brown crab was rarely observed. However a few newer nets were also retrieved one of these had 68 lobsters in the net and another net estimated to be around 1500 m long had 3-400 brown crabs.

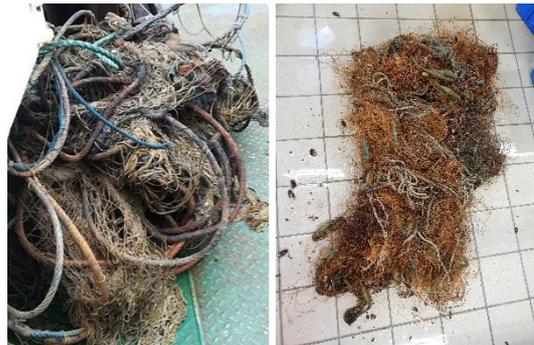
Eksempler på net stykker fanget under BITS/IBTS togter. Tv. En trawl. Th. et garn

Tabel 1. Antal net stykker og line stykker registeret under IBTS og BITS togter i perioden 2011-foråret 2021.
